REKONSTRUKCE JAROVSKÉHO ŽELEZNIČNÍHO TUNELU

RECONSTRUCTION OF THE JAROV RAIL TUNNEL

OTAKAR HASÍK, MIROSLAV CHYBA

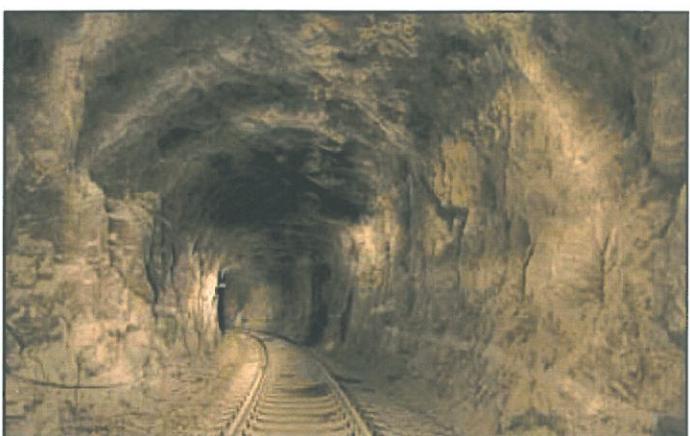
Obr. 2 Hlavní část tunelu je ponechána bez ostění
Fig. 2 The main part of the rock excavation is left unlined

The 393m long tunnel is provided with a lining only in about 70m long portal sections, whilst the rock surface in the main part of the tunnel is bare (see Fig. 2). The lining of the portal on the side toward the village of Vranné n. Vltavou was in an emergency condition; the initial 40m long section of the tunnel was supported by steel frames and wooden lagging. The speed of passing trains was restricted to 10 km/h.

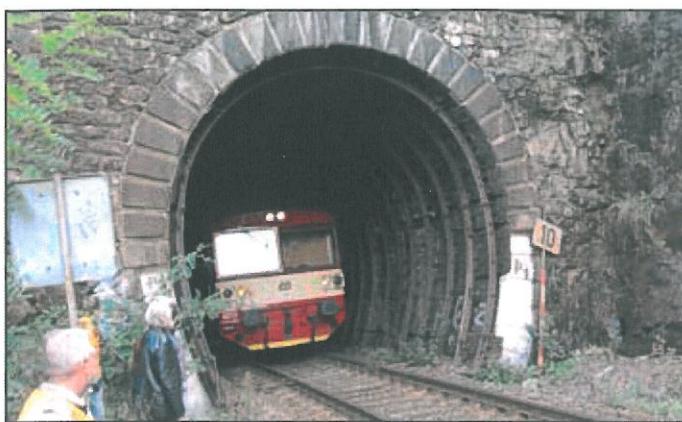
Obr. 3 Portál a prvních 40 m s provizorním zajištěním
Fig. 3 The portal and initial 40m with a temporary support

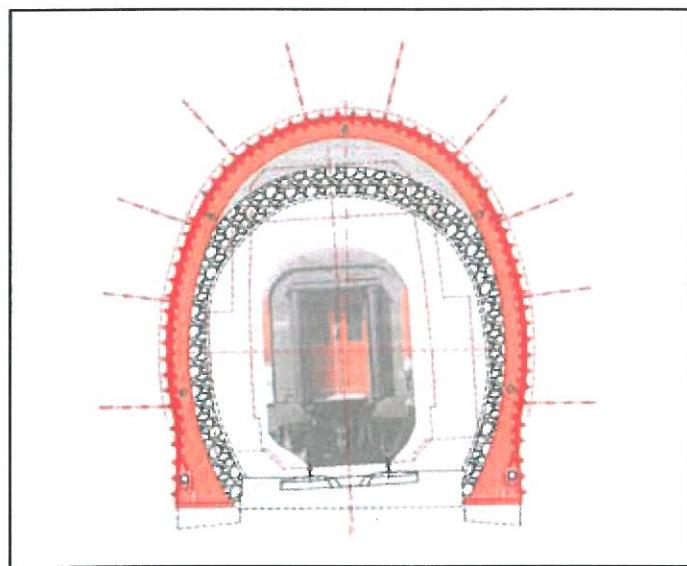
Obr. 4 Příčný řez původního a rekonstruovaného tunelu
Fig. 4 A cross section of the original tunnel and reconstructed tunnel

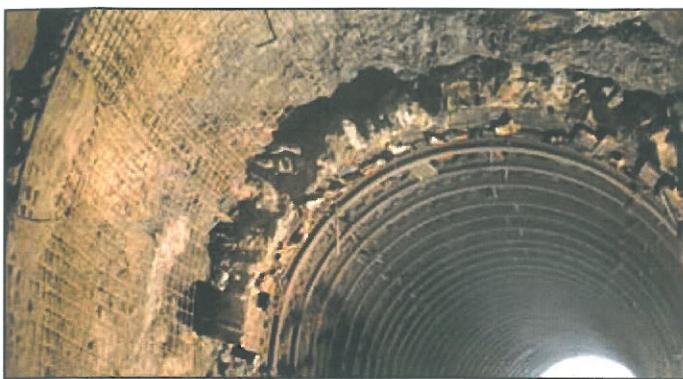
Obr. 5 Detail pobírání skalního masivu a původní obezdívky
Fig. 5 A detail of the breaking of the rock and the original masonry lining

The steel frames and wooden lagging forming the temporary support were removed stepwise, in individual advances proceeding from the tunnel interior toward the tunnel portal, the existing masonry lining was removed first in the vault and then on the sides and the excavated cross section was enlarged in the crown to the required shape. The installation of the temporary support followed. It consisted of the surrounding rock mass which was reinforced by anchors and a 50 – 100mm thick layer of C 20/25 sprayed concrete with one layer of steel mesh.

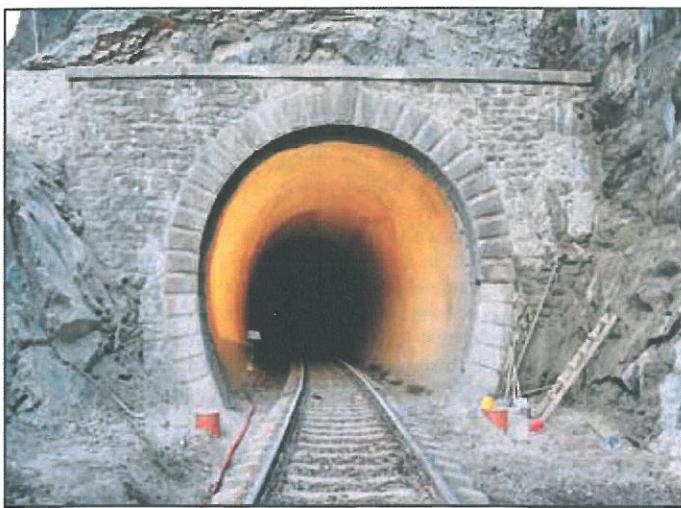
Obr. 6 Rekonstruovaný tunel
Fig. 6. The tunnel after reconstruction
